Geophysical Investigation of Damped Patches on Foundational Wall: A Case Study of Jalala, Tanke-Oke-Odo, Ilorin, Nigeria

Abstract— The issue of dampness in buildings in Jalala Oke-Odo, Ilorin, Kwara State, Nigeria, poses significant concerns due to its potential to compromise both the health of occupants and the structural integrity of affected buildings. To investigate the underlying causes of this widespread problem, non-destructive geophysical methods—particularly the Electrical Resistivity Method—were employed to assess soil and subsurface conditions. This approach enabled the identification of anomalies in soil composition and the detection of subsurface water sources contributing to dampness. A key objective of the study was to produce detailed subsurface maps around building foundations, providing engineers and contractors with critical data for designing targeted interventions to mitigate damp-related issues and prevent long-term structural damage. The study underscores the serious risks associated with prolonged dampness, including the progressive weakening of foundation walls and the potential for building collapse, posing a grave threat to resident safety. Resistivity m

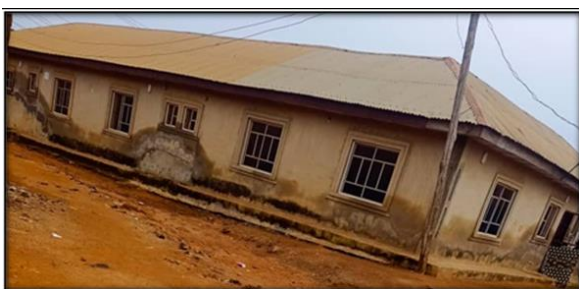
Figure 2: Example of wall Dampness.

If the surrounding soil does not have proper grading or the gutters and downspouts are not directing water away from the foundation, excess moisture can accumulate around the walls and seep into the interior. Example of dampness in building wall is shown below (Figure 2).

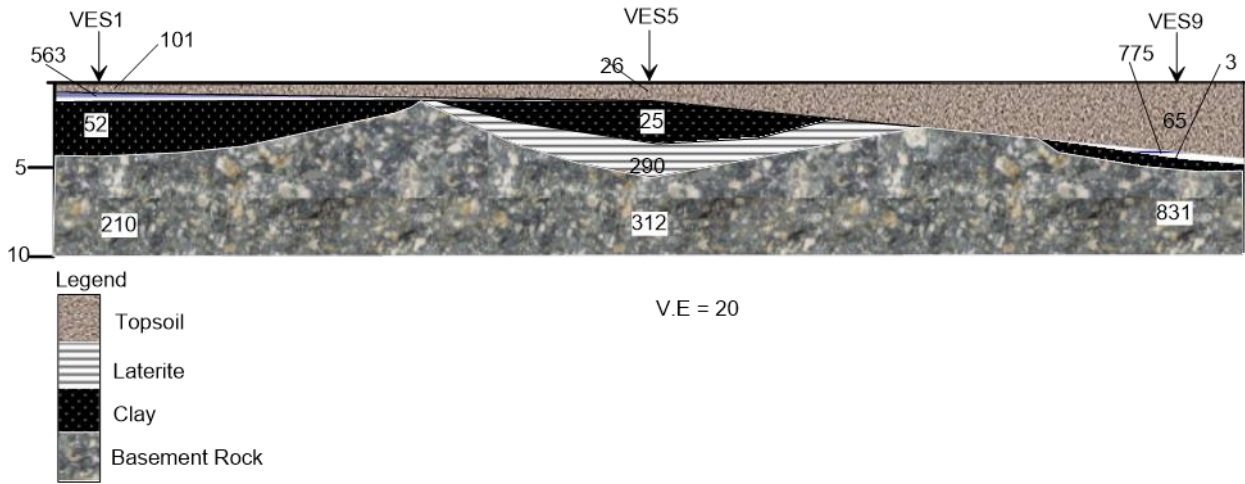
Figure 4: Profile 1

This profile consists of 3 VES points as listed above, 4 geoelectric layers were recorded

across the section which includes topsoil, lateritic layer, clay and the basement rock. The top soil resistivity varying from 26 Ω m to 101 Ω m with thickness ranging from 0.6m to 4.7 m. lateric layer resistivity varies from 290 Ω m to 775 Ω m maximum thickness of 2.7 m across the section. The clayey medium resistivity varies from 3 Ω m to 52 Ω m with thickness ranging from 0.5 m to 3.3 m, while the bedrock has a resistivity ranging from 210 Ω m to 831 Ω m.

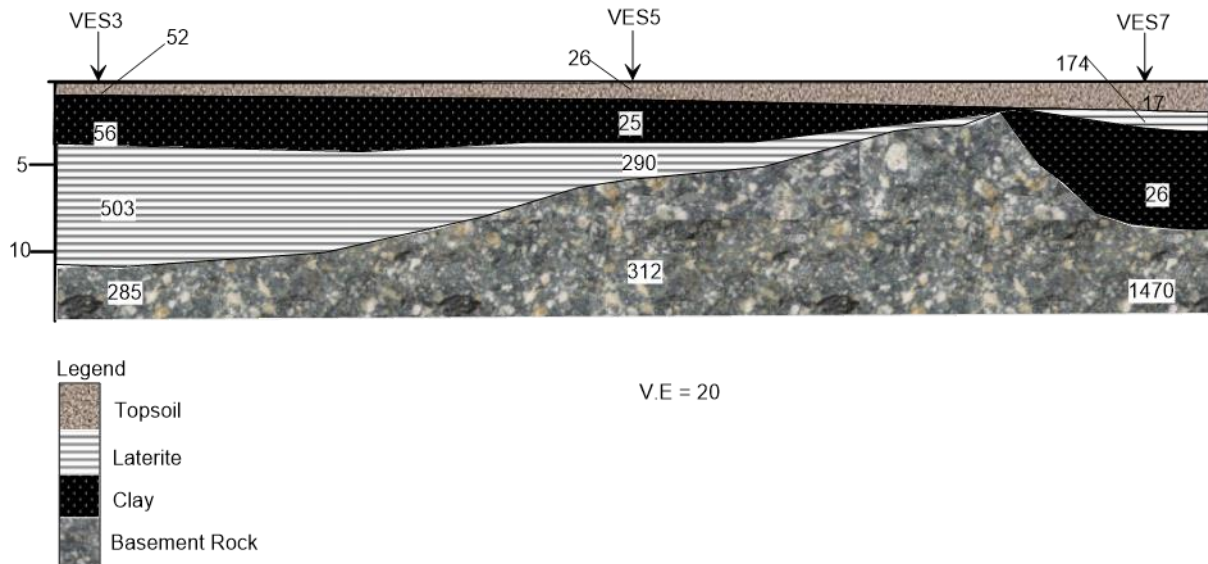
Figure 5: Profile 2

This profile cut across VES 3,5 and 7, total number of 4 geoelectric layers were recorded across the section which includes topsoil, lateritic layer, clay and the fresh bedrock. The top soil resistivity varies from 17 Ωm to 52 Ωm with thickness ranging from 0.1 m to 1.4 m. The clayey layer resistivity varies from 26 Ωm to 56 Ωm with thickness ranging from 2.7 m to 5.7 m. Lateric layer resistivity varies from 174 Ωm to 503 Ωm with maximum thickness of 7.2 m. and the fresh bedrock has a resistivity ranging from 285 Ωm to 1470 Ωm .

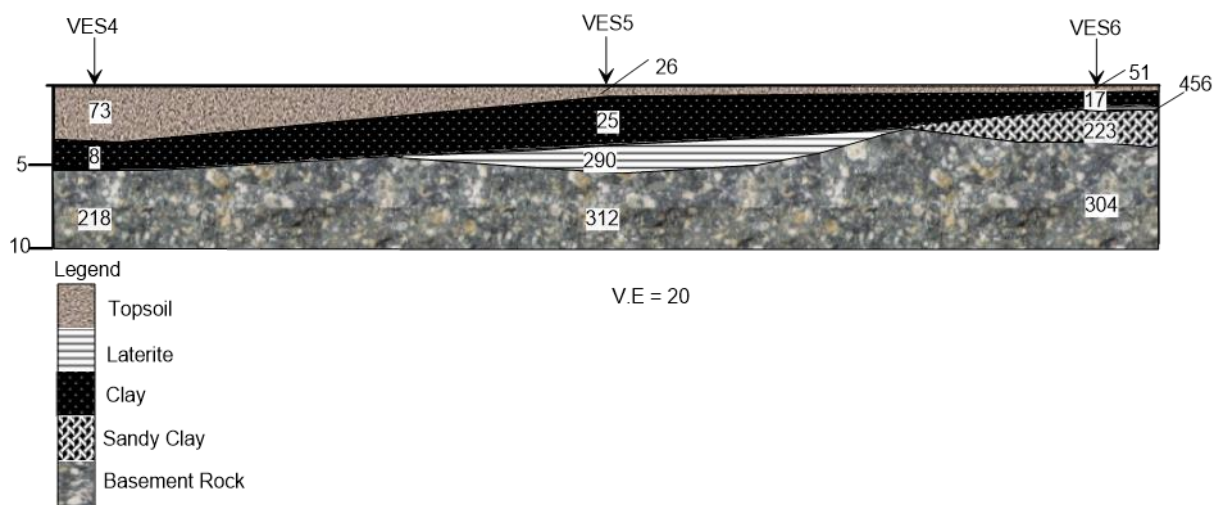
Figure 6: Profile 3

Profile 3 comprises of 3 VES points in which 4 to 5 geoelectric layers were generated which consist of topsoil, laterite, clay, sandy clay and the fresh bedrock. The topsoil resistivity value varies from 26 Ωm to 73 Ωm thick, ranging from 0.8 m to 3.5 m, the laterite was recorded in VES 5 and 6 with resistivity of 290 Ωm and 456 Ωm with maximum thickness of 2 m, the clayey layer serve as the second layer across this section with resistivity with varying from 8 Ωm to 25 Ωm and thickness of 1.2 m to 2.7 m. Sandy clay with resistivity value of 223 Ωm and maximum thickness of 2.5 m was recorded in VES 6 underlain by the fresh bedrock.

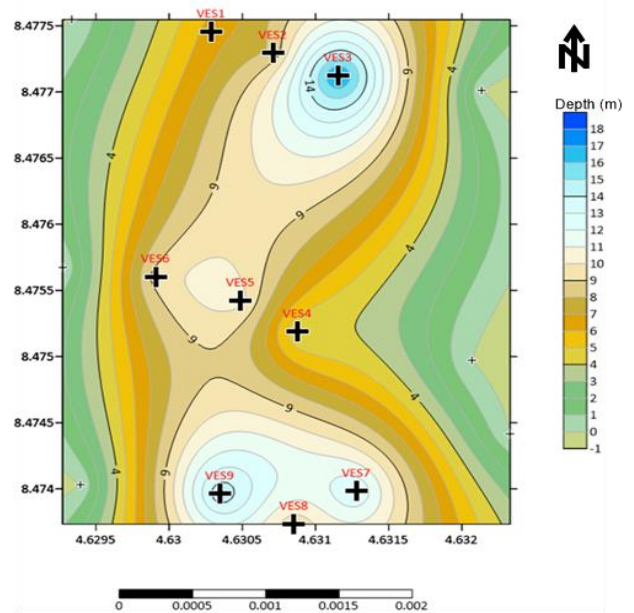
Figure 7: Contour Map of Depth to Basement

To have a clearer view about the subsurface information, The thickness and resistivity map of the depth to the basement were generated (Figure 7 and 8), the depth to the basement rock ranges from less than 1 m to 18 m with an average of 5 m in most part of the study area. The area around VES 3,7,9, shows depth above 9 m. Figure 8 indicates low resistivity within the overburden thickness across most part of the study area, with resistivity values less than 300 Ωm in most part of the study area.

Figures 7 and 8 have shown and given reasonable idea on the overburden materials content. It has also indicated that the overburden consists of weathered rocks types e.g. clay, sandy clay, etc. with their peculiar engineering characteristics.

The interpreted data indicates a generally low resistivity value in most cases with clay materials being inferred in many cases. The overburden materials from second layer to the top of the basement being semi-permeable layers (clay and laterite) which retain water and of course perpetuate the wetness to the surroundings.

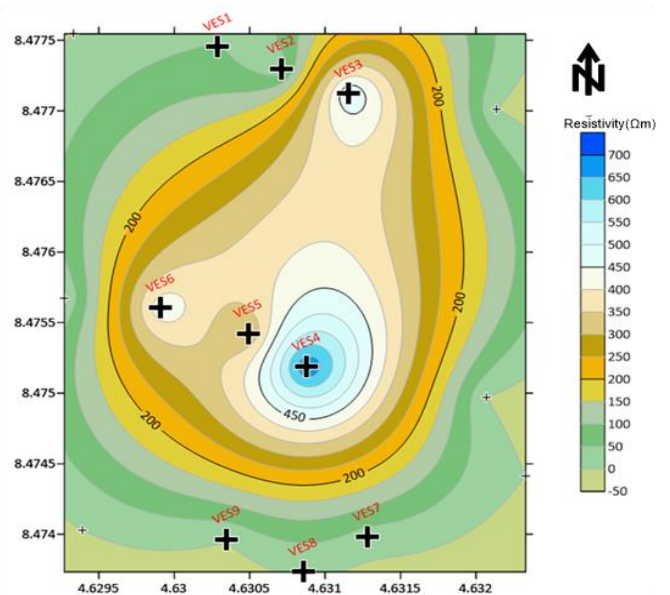
mainly due to semi-permeable clayey overburden materials retaining water.
