Geophysical Investigation of Damped Patches on Foundational Wall: A Case Study of Jalala, Tanke-Oke-Odo, Ilorin, Nigeria

Abstract— The issue of dampness in buildings in Jalala Oke-Odo, Ilorin, Kwara State, Nigeria, poses significant concerns due to its potential to compromise both the health of occupants and the structural integrity of affected buildings. To investigate the underlying causes of this widespread problem, non-destructive geophysical methods—particularly the Electrical Resistivity Method—were employed to assess soil and subsurface conditions. This approach enabled the identification of anomalies in soil composition and the detection of subsurface water sources contributing to dampness. A key objective of the study was to produce detailed subsurface maps around building foundations, providing engineers and contractors with critical data for designing targeted interventions to mitigate damp-related issues and prevent long-term structural damage. The study underscores the serious risks associated with prolonged dampness, including the progressive weakening of foundation walls and the potential for building collapse, posing a grave threat to resident safety. Resistivity m

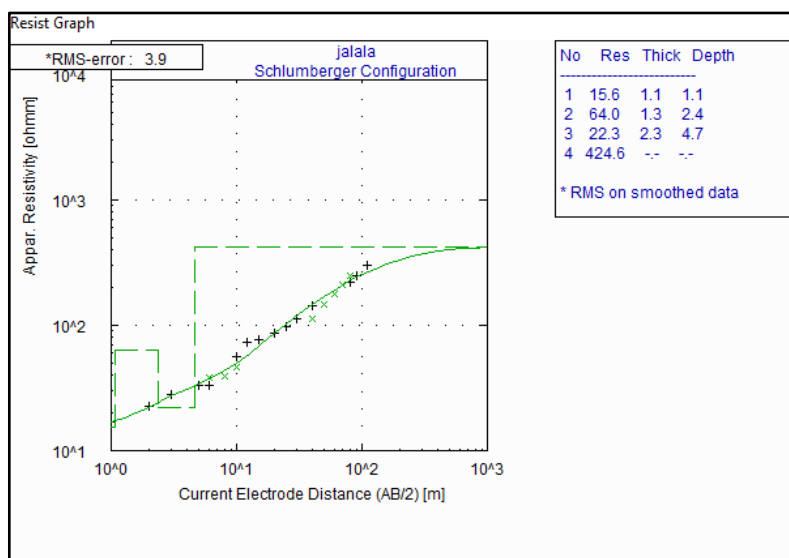
Figure 3: Typical KH curve (VES 2)

The sounding curves from these readings varies from 3 layer to 4 layers curves with KH curve type being the only curve generated twice (Figure 3).
